The Yachtsman's Pilot

SKYE AND NW SCOTLAND

Supplement No.3

March 2007
2nd edition 2002
ISBN 0 85288 606 3

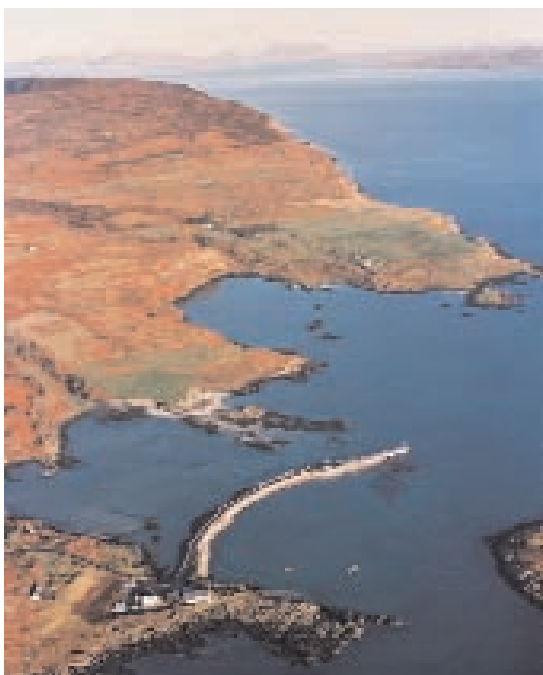
Above Eigg, new ferry terminal
Below Eigg, yacht berth on north side of ferry terminal
